STURNARD[®] **SPOTLIGHT** STONHARD PROVIDES LONG-TERM FLOOR AND DRAIN SOLUTION

Problem: Moisture in concrete

Scope of work: Washroom

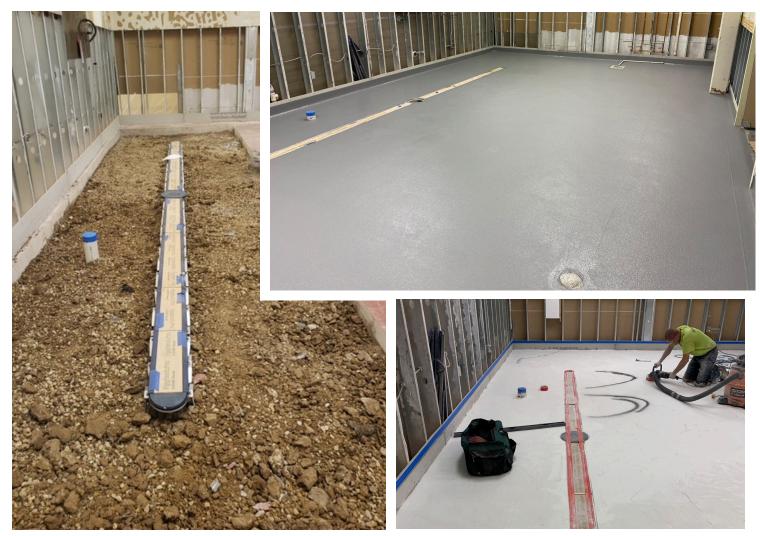
Product Solution: Stonclad® UT, Stonfil® OP2, Blücher Drains

For this project, Stonhard undertook all aspects from concrete removal and new plumbing to concrete pour-back and flooring system installation.

Our Construction Management Group sent an onsite superintendent to oversee the job and focus on every detail of the installation and its schedule. Prior to the concrete pour, a Blücher drain with plastic insert was put in place. The concrete was then sloped a quarter of an inch per foot around the drain to ensure against the pooling of water. The plastic insert was removed after the concrete had cured to create a chase detail for the poured-inplace floor to be installed flush with the drain.

Stonhard flooring systems can be installed on "green" concrete, five days after pour-back, limiting loss of operating time for customers. Stonfil OP2, our moisture mitigating grout, was used to alleviate any moisture concerns moving forward and Stonclad UT, a high-performance urethane mortar flooring system, was identified as the best option for the customer.
